INCREASING SUSTAINABILITY THROUGH CONSOLIDATION WORKS AND DEGRADATION STABILISATION OF THE ROMANIAN ORTHODOX CATHEDRAL IN GHELAR

Abstract

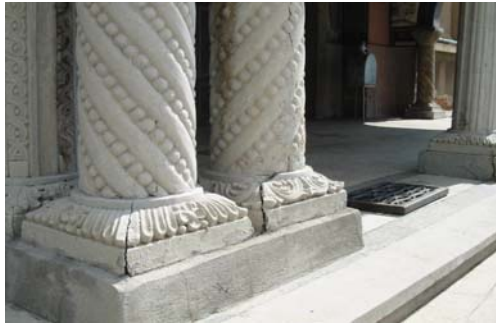
Fig.2. Cracks/open joint fissures at columns

- fissures and cracks in the stairs: main, secondary, side and back, with the tendency to detach from the building;
- the left side pillar is very fissured and has the tendency to lose stability;

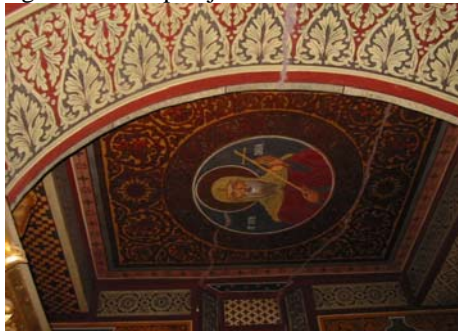
Fig.3. Cracks at arches and vaults

- fissures and cracks in the brick vaults – at the heading stone, in the field, at the springings;
- fissures and cracks in the window-recesses between the windows of the exterior longitudinal walls, in the heads of the window, in the parapet beams, and in the cornice;

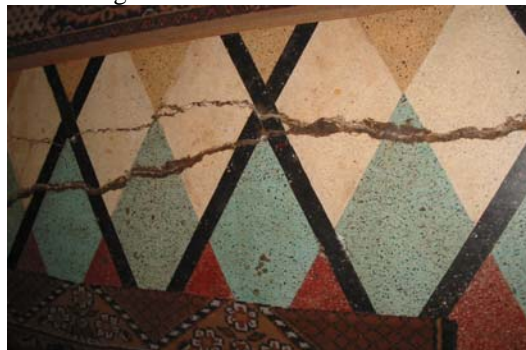
Fig.4. Cracks in the floor

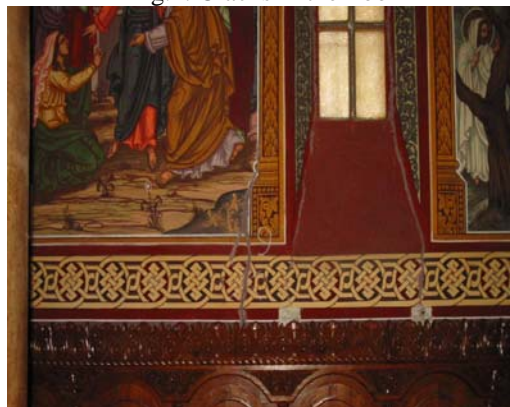
Fig.5. Cracks in parapet beams and walls

- shearing sections of the empty spaces between the windows and the external walls;
- fissures and cracks in the parapet beams of the inner balconies;
- fissures and cracks in the floors;
