STUDY OF THE EFFECTS OF A HIGH EARTH EMBANKMENT ON A NEARBY BUILT-UP LAND

Prada Marcela*, Tudor Dan**

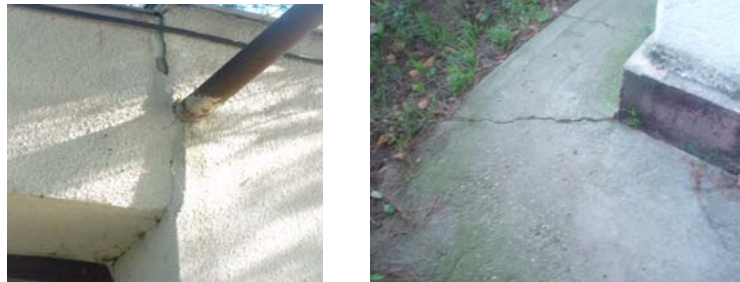
Fig.3. Initial degradation

Initial assessment of the building. The building is in risk class R III, falling under the effect of earthquake engineering design that can suffer major structural damage, but the loss of stability is unlikely.

Therefore the above assessment it can be concluded that the current infrastructure of the building may be appropriate, but supra-structure, given that investor proposed interventions produce differentiated settlements on the east side building is not rigid enough to take these actions more. Fig. 4 indicate that there are cracks in the beam stands zone on the column and also sidewalk cracks. It takes into account the existing round strips slabs without reinforced concrete finishing (according P100-2006), which not provides "significant stiffness in plan" and lack of bracing walls in the transverse direction to the building. Following initial assessment is recommended:

- Making bracing walls in transverse direction of the building for enrolment it in a class above the present seismic risk. These walls will need to have independent foundations from the current foundations, to ensure cooperation with existing reinforced concrete walls or pillars in front.
- Consolidation of degraded areas of columns and of reinforced concrete beams that cracks in exploitation, by strengthening with reinforced concrete or carbon fiber lining and metal tie rods.
- In order to improve the behavior of structural elements to potentially seismic action or other outdoor activities, it is recommended to anchor the existing "floating" independent structure elements, such as existing chimney.
- To eliminate infiltration of rainwater in front or inside, we recommend restoring proper roof terrace and its connection to the attic perimeter.

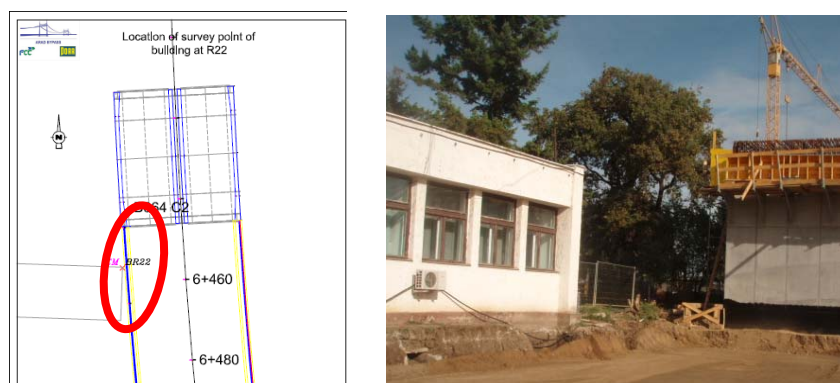
Fig.4. Location of survey point of building

- track foundation tamping of adjacent facade to the new building, where they ordered two landmarks on the top level of foundation corner;
- visual track of cracks in structural and non-structural (ex. partition walls) elements.

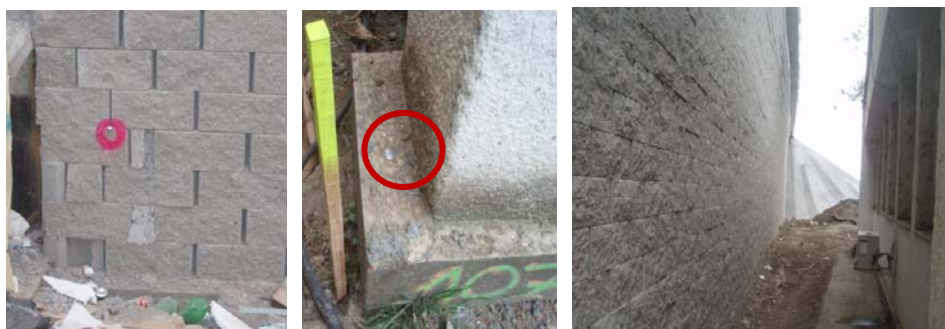
Fig.5. Highlights wall support and on the foundation pillar

Follow subsidence: They ordered two landmarks on the foundations of the pillars corner facade as planned layout guidelines. Evolution of the foundation settling time closest support wall slope is shown in Table 1. It can be seen jumping reading level dated 18.12.2011 till 09.01.2012 on it due to the entry into service of the highway section. Following the occurrence of road traffic (especially transit vehicles, cargo transport) resulted in a significant difference in level between the two readings.

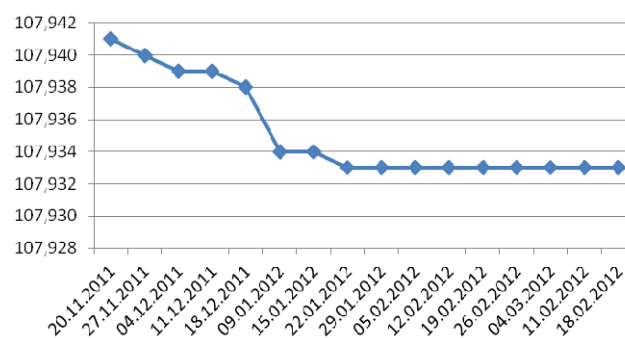
Fig.6. Settling time evolution

In fig. 6 is shown diagram that shows the evolution over time of Anraz building subsidence in the adjacent wall support:

After 18.02.2012, subsidence evolved slowly, noticing their increased approx. 2mm, according to the latest reading from 04.10.2012:

It can be appreciated that in July-September. 2012, settlements phenomenon were stabilized but can be reactivated at environmental conditions modification (autumn-winter rain / abundant snow, etc).

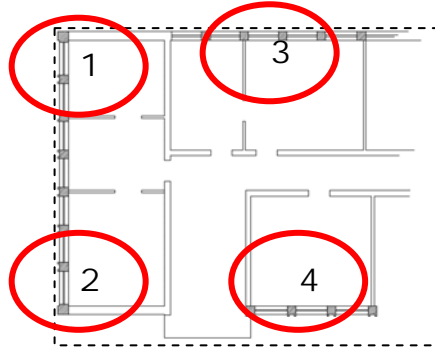
Fig.11. Major problem areas

During May-June 2012, there were intensive aggravation of damages / cracks in structural and non-structural elements, with serious consequences for local resilience and stability of the building. Phenomena of subsidence of foundations in Eastern facade, confirmed by topographical measurements were generated:

- local breaking links between beams and columns facades their discharge in the building close to route highway slope, the slope of influential, especially in North facade, fissures / cracks in interior walls (non-portable), generated by rotating end of the building to support the embankment wall;
- fissures / cracks in lintels; breakings in attic of the terrace, in active area of the building.
- cracks at the interface between the floor strips and interior walls parallel to the strips;

Affected areas listed below have not included nonstructural walls. The areas most affected by compaction foundations of the Eastern facade with extension to the foundations of the South and North facades, are at the corners of the building and to the limit separation of significantly different rigidities from structural compliance of the building, due turning to slope of the building section, too.

Is estimated the probability of front bearing beams local rupture, their fall from their supports with engaging strips download onto these beams.

- Providing supports for the beams of the facade, in areas with major faults. (Marked with 1, 2, 3, 4, in the failure plan).
- Introduction of cooperation tyrants, between front and corner.
- Injection areas with cracks / crevices with question-recommended grout at least, special mortar injection (SIKA type resin mortar, or similar, etc) in an appropriate technology to restore and protect local structural continuity heads fittings.
