THE INFLUENCES OF THE SLOPE AND MATTRESSES ON EROSION IN THE FORMER BAUXITE QUARRY FROM THE PADUREA CRAIULUI MOUNTAIN

Radu Brejea, C. Domuta*

*University of Oradea, Faculty of Environmental Protection, 26 Gen. Magheru St., 410048 Oradea; Romania, e-mail: rbrejea@yahoo.com

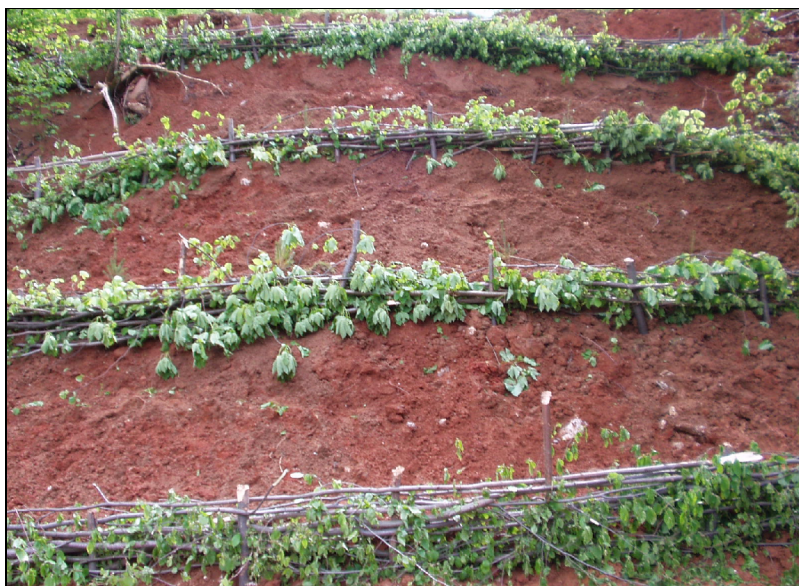
Figure. 1. Beech tree mattress after being set up (2004),
in the former bauxite quarry from Zece Hotare, Bihor

cm in dimension, and 6.0 kg of manure was used for each hole. In order to ensure a high rate of plant development, right after being put into the ground they were watered with 16.0 l water each. On the hillside of the quarry, mattress was made out of oak stakes and beech rods at meters distance in order to prevent soil erosion (figure 1).

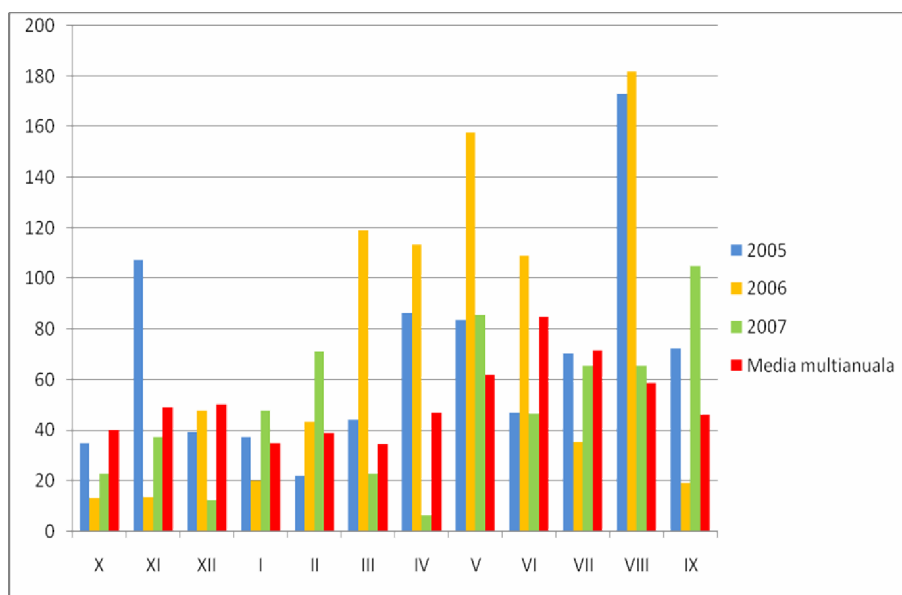
Figure 2 Monthly values (mm) of the rainfall registered in the area of the former bauxite quarry from
Zece Hotare 2005 - 2007

The multiannual average of the rainfall in the Zece Hotare area is of 615,1 mm. The biggest monthly quantity of the rainfall is registered in June, usually ,84,7 mm. In the research period, the year with the biggest quantity of rainfall was 2006, 872,0 mm; 815,8 mm were registered in 2005 and the most droughty year was 2007, with 585,2 mm, only. (figure 2). The rainfall registered in 24 hours were used for emphasizing the rainfall aggressi velly under the hillside of the former bauxite quarry

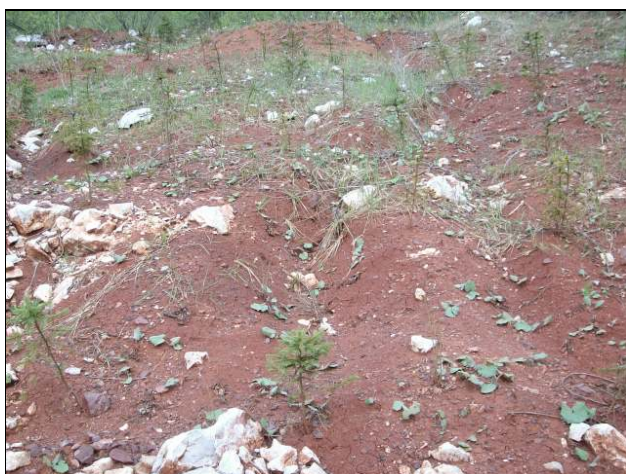
Fig. 3 Aspect with erosion on the hillside with slope of 10 % without mattresses and with spur – tree planted

Aspects from the locations of the experiments are presented in the figure 3 and 4.

We can observe the land erosion and small degree of vegetation covering on the hillside without mattresses and high degree of vegetation covering and low erosion on the hillside wich was arranged with mattresses.

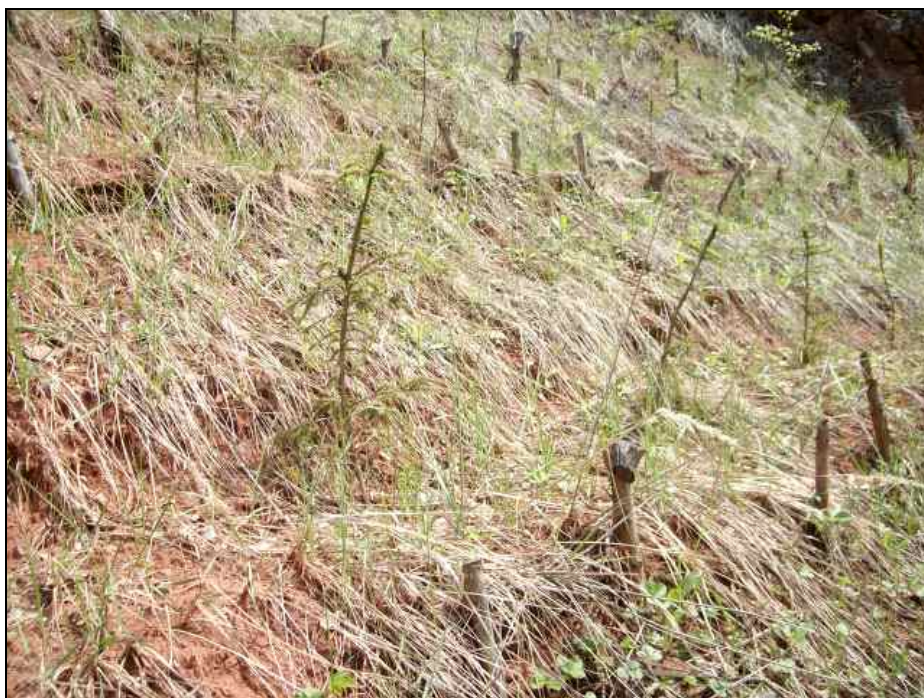
Fig. 4 Aspect with erosion on the hillside with slope of 10 % with mattresses and with spur – tree planted
