EFFECTS OF USING DEPTH WATER FROM A FRUIT FARM PLACEMENT ON THE BUILDING SITE

Prada Marcela

Abstract

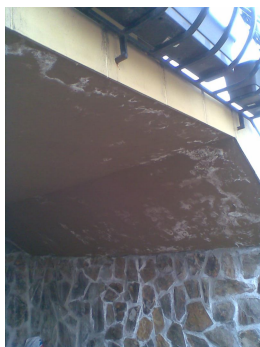
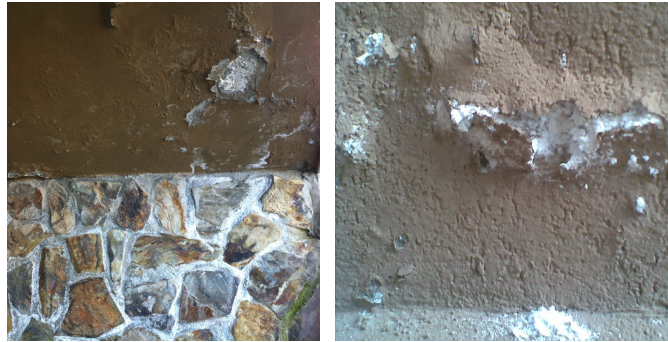
Fig. 4 Carbonation phenomenon

Effects of using water from drilling on building achievement from this placement, were studied. These were revealed on the building façade, after 3 years of finishing construction. Images showing carbonating phenomenon both on building façade, and plywood joints of natural stone from façade, are relevant (fig. 4).

Carbonating phenomenon is very common in construction. Given that using treated water on plasters, concrete and mortars achievement, appearance conforms to standards, environmental conditions being the same, it is recommended to avoid untreated water usage from drilling, on building construction. It is mentioned that water chemistry is the result of using chemical treatments on this placement, over 30 years. It is

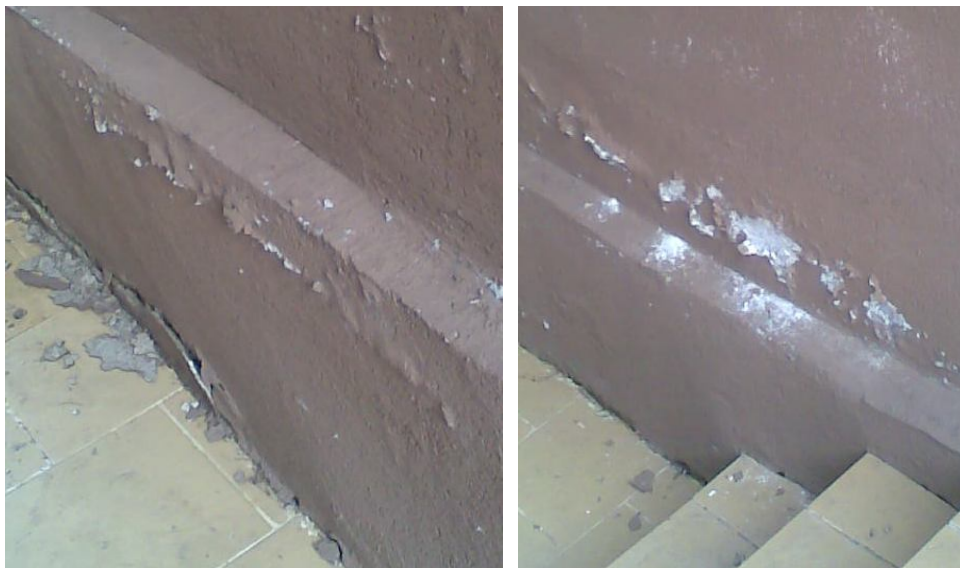
Also, carbonating phenomenon is visible sideways of the constructive elements, which are into direct contact with soil from this placement (retaining wall) (fig.5).

Fig.5 Case study, carbonation phenomenon at the retaining walls

recommended also that construction elements not get into direct contact with water respectively with soil on this placement. This is applicable to retaining walls and building infrastructure.

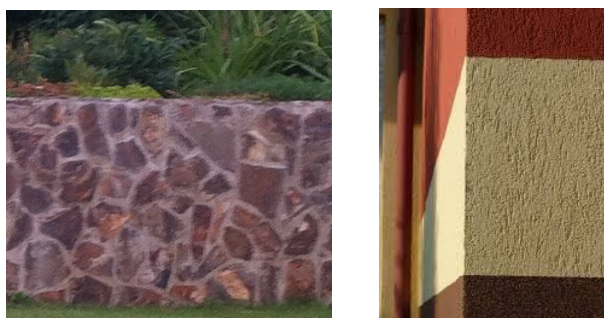
Using chemically treated water on faade mortars and plywood joints of natural stone achievement, appearance conforms to standards, and carbonation phenomenon is not visible (fig. 6).

Fig.6 No carbonation. Standard appearance.
